## KL0S Shack Note #25

### RF Amplifier Power Supply Fix

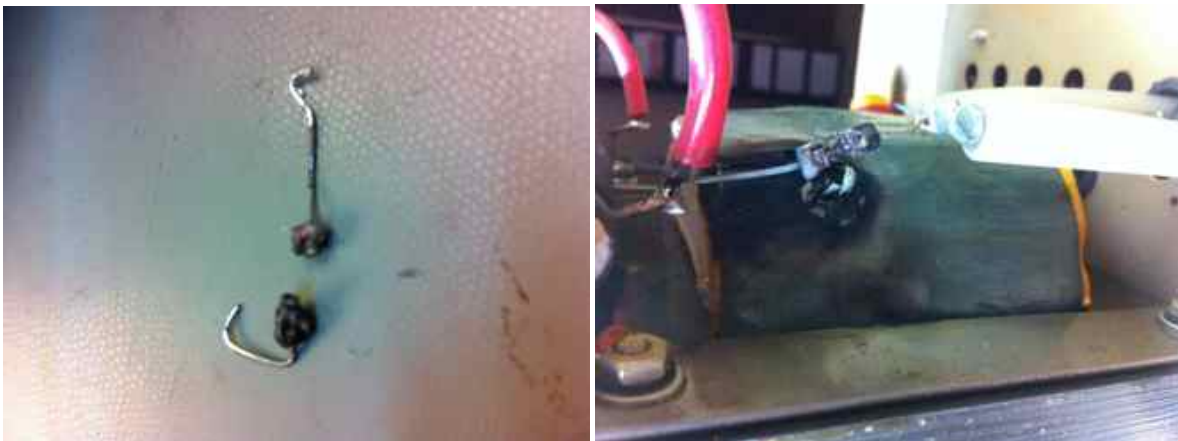
The Drake designers back in the day included a  $0.82\Omega$  2W resistor in the high voltage line that would act as a fuse in the event excessive current started to be drawn (normal plate current on SSB peaks runs  $\sim 600\text{mA}$ ). With the power supply cover off it was immediately apparent that the "resistor fuse" had done its job, well maybe a little too well, as in the process of blowing up it had actually burned the side of the large plate transformer.

*Failed resistor and transformer damage*

I removed the damaged resistor and cleaned up the charred transformer case material as best I could. My concern was that the damage may have extended down into the transformer's windings but I found no visible evidence of that.

Next, using the power supply's schematic, I checked the continuity of the transformer's primary and secondary windings; both measured less than  $1\Omega$  which told me that they were at least still intact and that the protection resistor may very well have done exactly what it was supposed to do (less burning the transformer case that is!). This was good news and I then turned my attention to the charred area. Using a sharp dental-pick style tool I removed as much of the charred material as I could without digging any deeper into the interior of the transformer. But what do you do with the gaping hole in its side? I thought that some kind of potting compound might work but didn't have anything like that available. Then I looked up at the workbench and saw that I did have a couple of bottles of "Liquid Electrical Tape" which is used to insulate wire connections and tool handles and thought maybe that would work. So I took a chance and filled the void with the red colored liquid and it quickly cured to an ugly but nice rubber consistency. I then replaced the resistor from a stock I keep on hand for just such a contingency in my own Drake amplifier power supply.

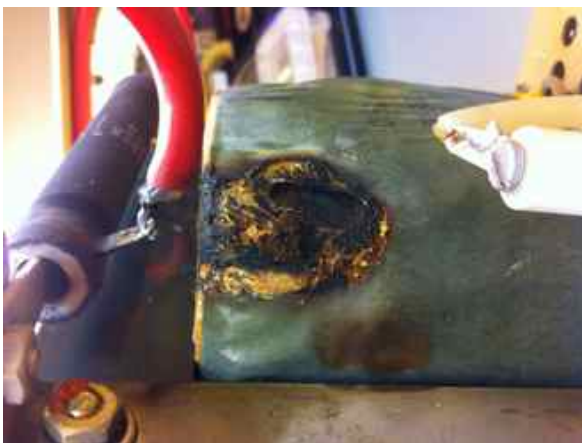
*Transformer case charring*

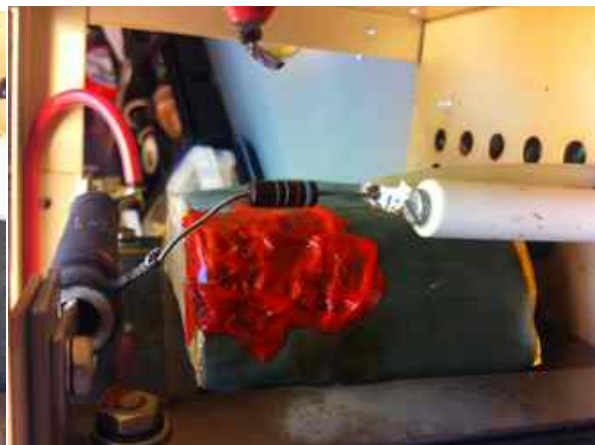
*Repaired casing – ugly but it works!*

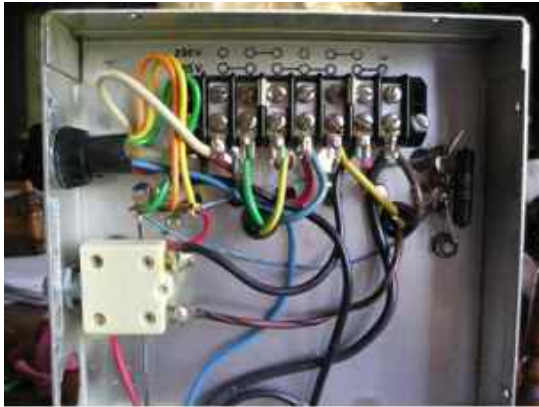
Next came a little electrical testing. The power supply can either be wired for 120VAC (not recommended) or 240VAC as this supply was configured. I simply wanted to see whether the transformer was still functional and I connected my Variac to the primary winding. The Variac will only supply up to about 130VAC but I figured that would be sufficient to verify the

*120/220VAC configuration area*

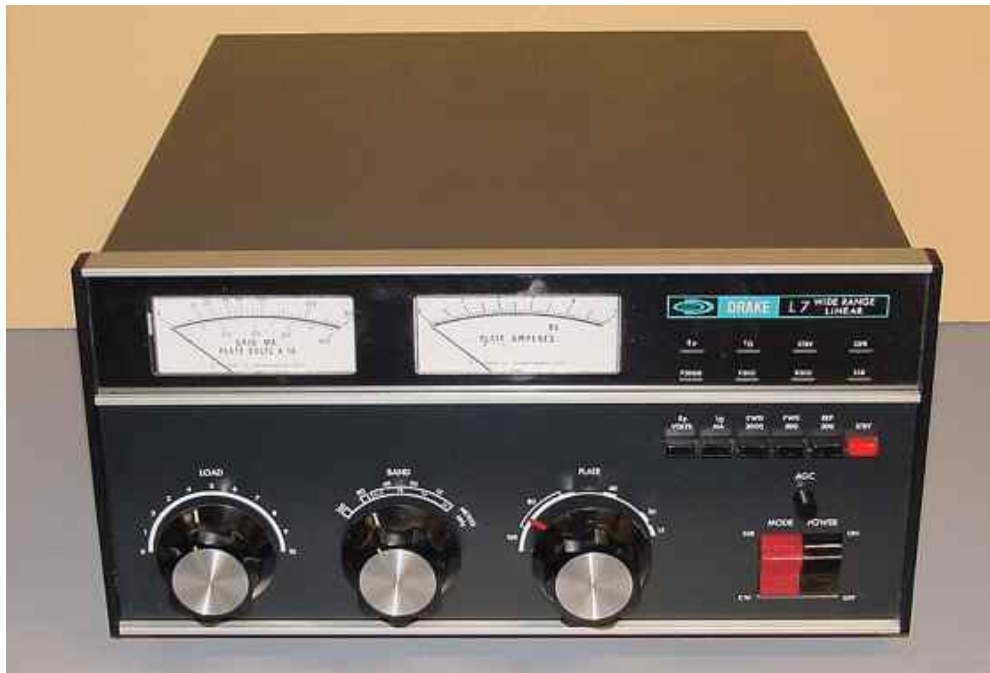
*The Drake L7 Amplifier circa 1981- an old workhorse that just keeps working!*

The only thing left to do was to plug in the repaired L7PS power supply and give it a go. With the power switch turned on the amplifier lit up just like it was supposed to. A quick check of the plate voltmeter showed the correct operating voltage levels and after tuning the amplifier up into a dummy load and running key-down for a short period of time without incident I was convinced that repair was successful.

Although society is rapidly adopting a "...throw it away, it's cheaper to just buy a new one" philosophy, we hams can still repair a lot of our own equipment with the proper know how and tools...besides that's part of the fun of it all. Sometimes a repair can be easy, sometimes not...this time we were lucky and the amplifier is now safely back at Gray's QTH and operational again.
